## CANADA GRANDVIEW PROJECT

Window Wall

Mock-Up Test Report / Window Wall

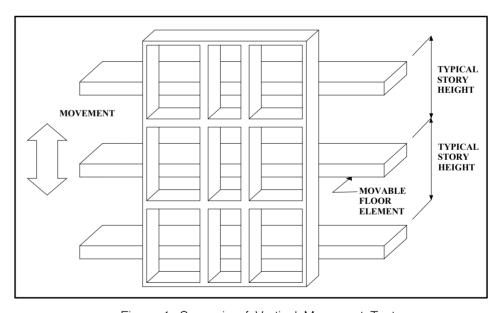
① Displacement: Up 15 mm Down 15 mm (Total 30 mm)

2 Cycle: 3 times

-. No glass breakage and no permanent damage to panels, fasteners or anchors.

Figure 1. Synopsis of Vertical Movement Test

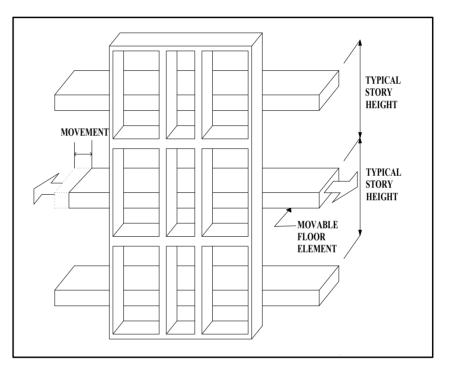
- ① Displacement: Left 30 mm Right 30 mm (Total 60 mm)
- ② Cycle: 3 times
- 3 Allowance :
  - -. No visible damage to framing or trim components or assemblies is allowed
  - -. No glass breakage or glass fallout is allowed
  - -. Full disengagement of gaskets or weatherseals is not allowed at any location
  - -. Air infiltration and water penetration resistance shall remain within specified allowable limits without adjustments or repair, except as specifically noted herein
  - -. No wall components may fall off
- 4 Result : Pass

Figure 2. Synopsis of Horizontal Movement Test

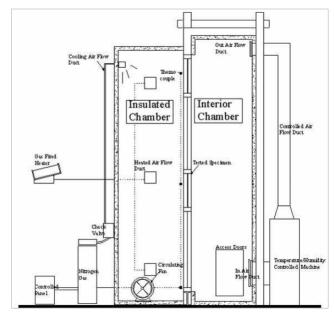
Out Door : Hot Cycle +82  $^{\circ}\mathrm{C}$  ± 3  $^{\circ}\mathrm{C}$  at Air Temperature

Cold Cycle -18  $^{\circ}$ C  $\pm$  3  $^{\circ}$ C at Air Temperature

In Door : +24  $^{\circ}$ C  $\pm$  3  $^{\circ}$ C

② Cycle: 3 Cycles

Figure 4. Synopsis of Thermal Cycling Test

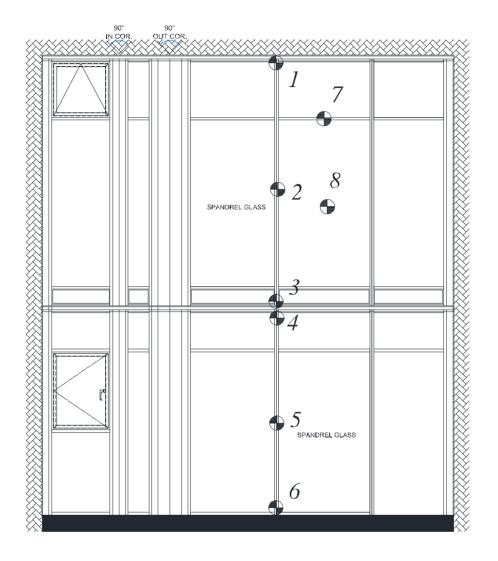
Figure 5. Transducer Location for Structural Test

No. 1: Top of Frame I
No. 2: Mid of Frame I
No. 3: Bottom of Frame I
No. 4: Top of Frame II
No. 5: Mid of Frame II
No. 6: Bottom of Frame II
No. 7: Mid of Frame III
No. 8: Center of Glass

4 Measured: Refer to Table 6 & Figure 5.

4 Measured: Refer to Table 8 & Figure 5.
