*Mock-up Test Report / Certificate No. 190314-033-1*

# CANADA GRANDVIEW PROJECT

Window Wall

## Mock-Up Test Report / Window Wall

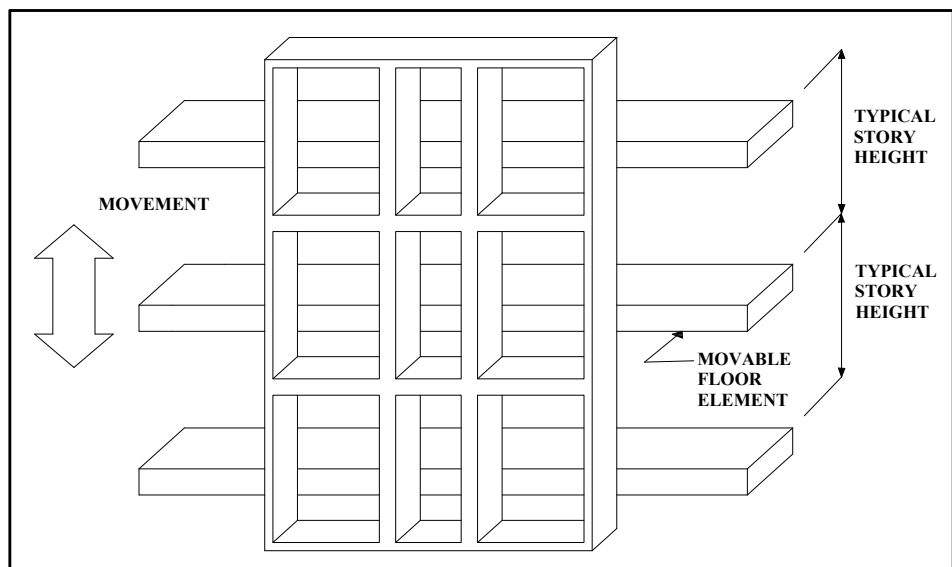
Figure 1. Synopsis of Vertical Movement Test

① Displacement : Up 15 mm Down 15 mm (Total 30 mm)

② Cycle : 3 times

- No glass breakage and no permanent damage to panels, fasteners or anchors.

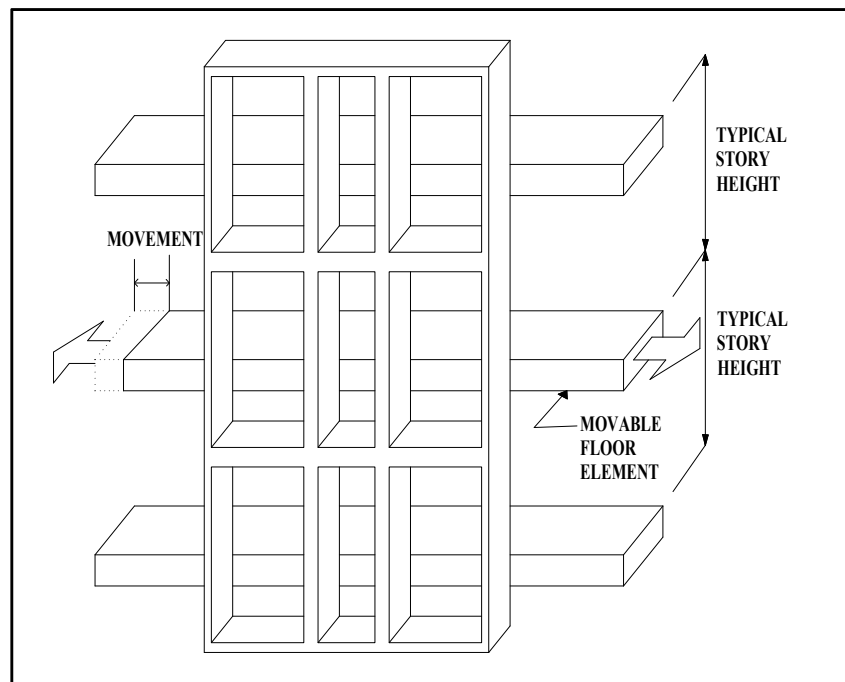
Figure 2. Synopsis of Horizontal Movement Test

① Displacement : Left 30 mm Right 30 mm (Total 60 mm)

② Cycle : 3 times

- No visible damage to framing or trim components or assemblies is allowed
- No glass breakage or glass fallout is allowed
- Full disengagement of gaskets or weatherseals is not allowed at any location
- Air infiltration and water penetration resistance shall remain within specified allowable limits without adjustments or repair, except as specifically noted herein
- No wall components may fall off

① Displacement : Left 45 mm Right 45 mm (Total 90 mm)

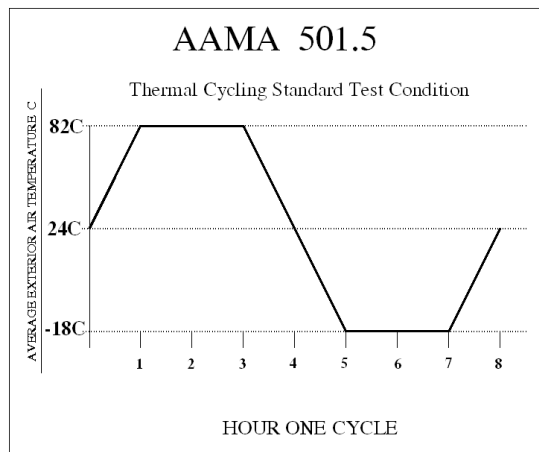
Figure 3. Synopsis of Exterior Temperature

Out Door : Hot Cycle  $+82\text{ }^{\circ}\text{C} \pm 3\text{ }^{\circ}\text{C}$  at Air Temperature

Cold Cycle  $-18\text{ }^{\circ}\text{C} \pm 3\text{ }^{\circ}\text{C}$  at Air Temperature

In Door :  $+24\text{ }^{\circ}\text{C} \pm 3\text{ }^{\circ}\text{C}$

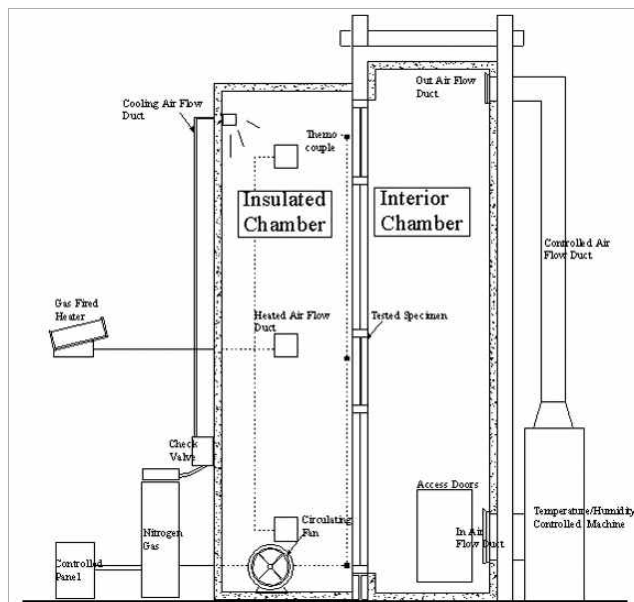
Figure 4. Synopsis of Thermal Cycling Test

① Test Condition

② Cycle : 3 Cycles

③ Allowance : After thermal cycling test, Air & water test was met the allowance.
