GRANDVIEW TEST REPORT

CAN/ULC S134, STANDARD METHOD OF FIRE TESTS OF EXTERIOR WALL ASSEMBLIES

G104543835SAT-001 R0

GRANDVIEW SERIES 35 ACM PANEL SYSTEM
ULC-S134 TESTING

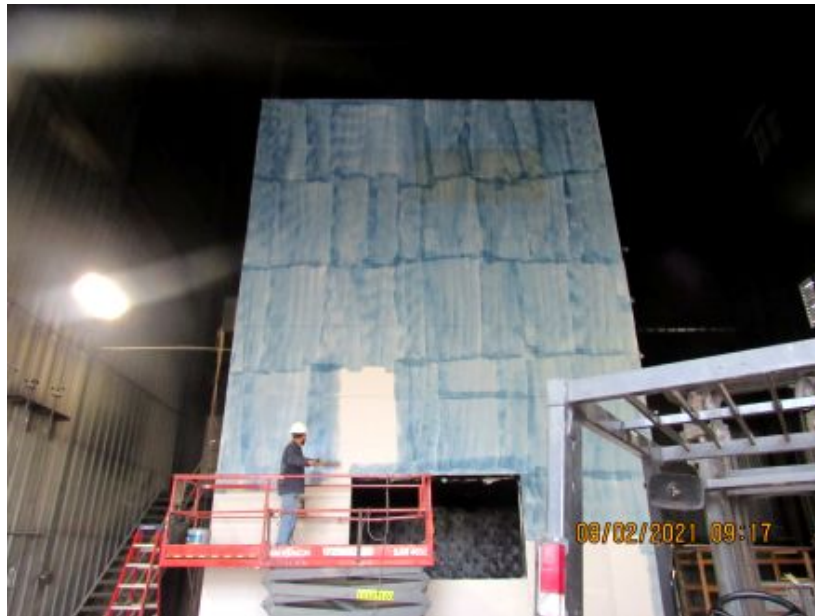
Photo No. 1
Primer installed

A thin coat of Henry Blueskin SA liquid primer was applied onto the sheathing with a roller. One layer of Henry Blueskin SA water resistive barrier (36" wide x 75' rolls) was installed over the primer with the long dimension oriented vertically on the wall and self-adhered into place.

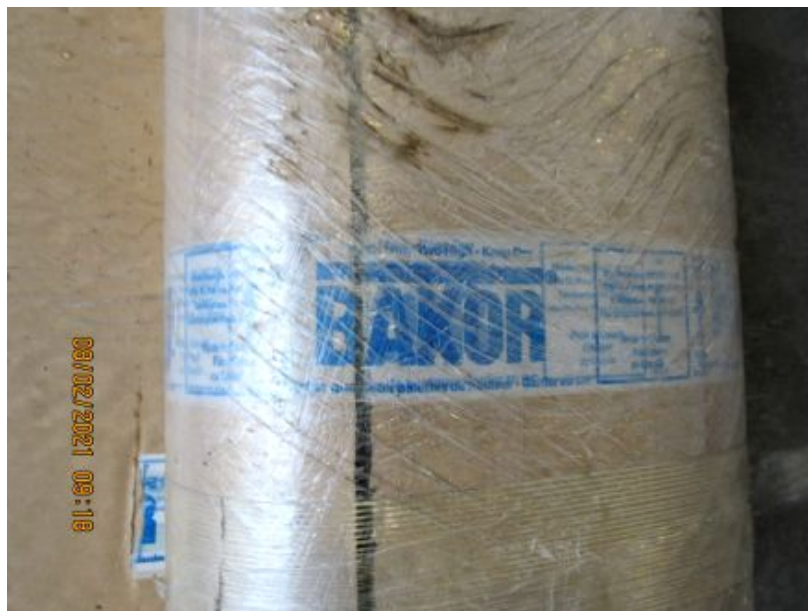
Photo No. 2
Vapor barrier

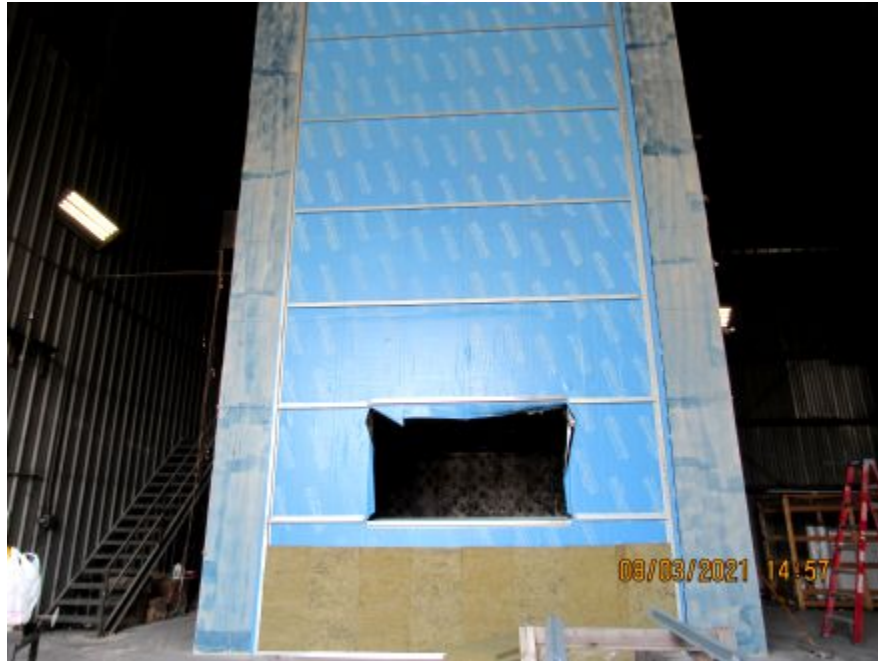
Photo No. 3
Vapor barrier installed with z girts

18 GA galvanized steel, 1-1/2 in. x 2 in. x 1-1/2 in. z-bar was installed onto the vapor barrier, spaced at nominal 60 in. up the entire wall assembly. 18 GA galvanized steel, 3 in. x 2 in. x 2 in. J-bar was installed at the base of the wall, windowsill and header, and at the top of the wall. The Z-bars and J-bars were installed using 1/4 in. x 2 in. concrete screw anchors, spaced at 16 in. o.c.

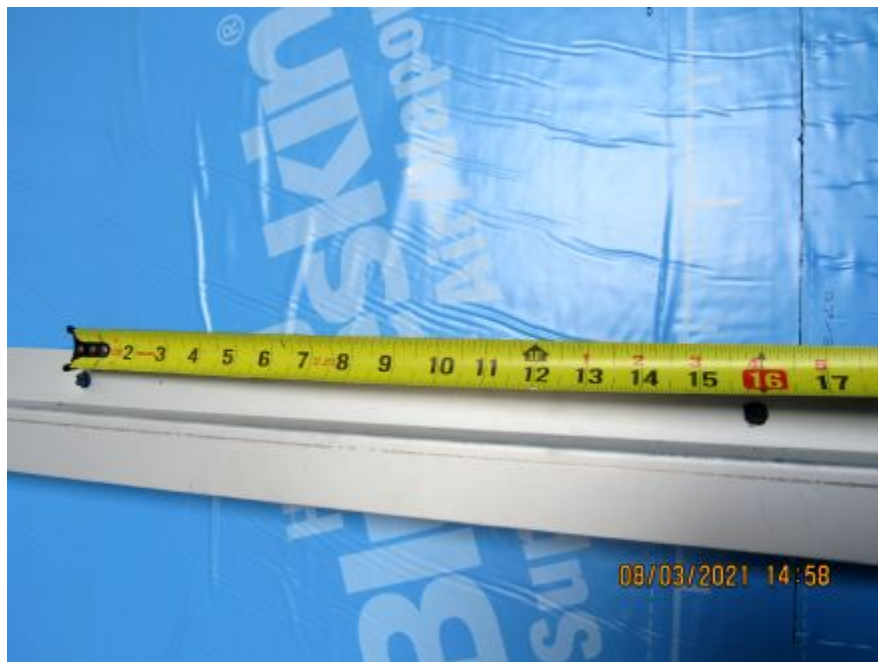
Photo No. 4
Z girt attachment spacing

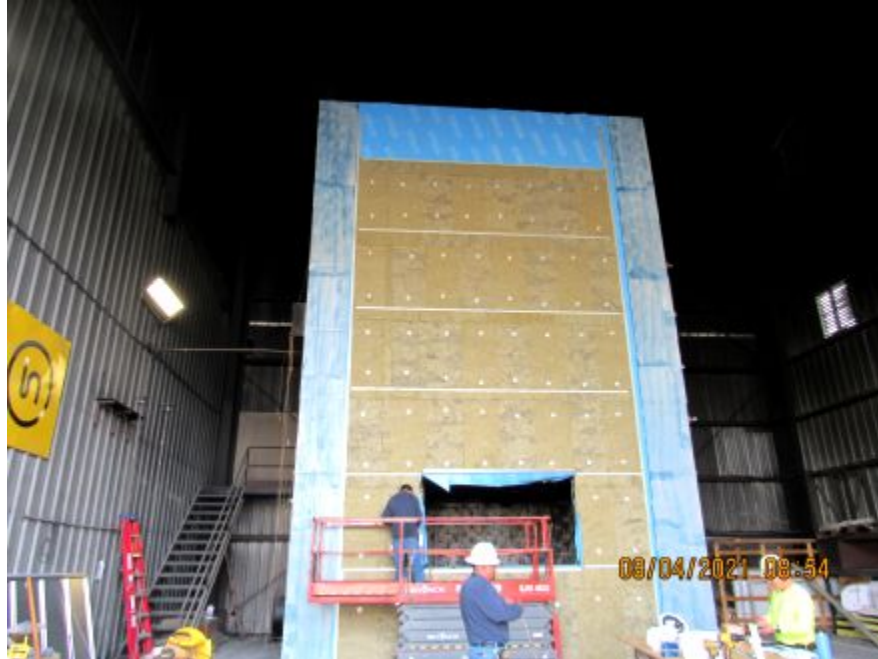
Photo No. 5
Insulation installed

24 in. x 48 in. x 2 in. thick mineral wool, with a density of 4 pcf, was used between the vapor barrier and ACM panel, held in place with 3-3/4 in. long concrete anchors and 2-inch wide round washers, using two fasteners and washers per piece of insulation

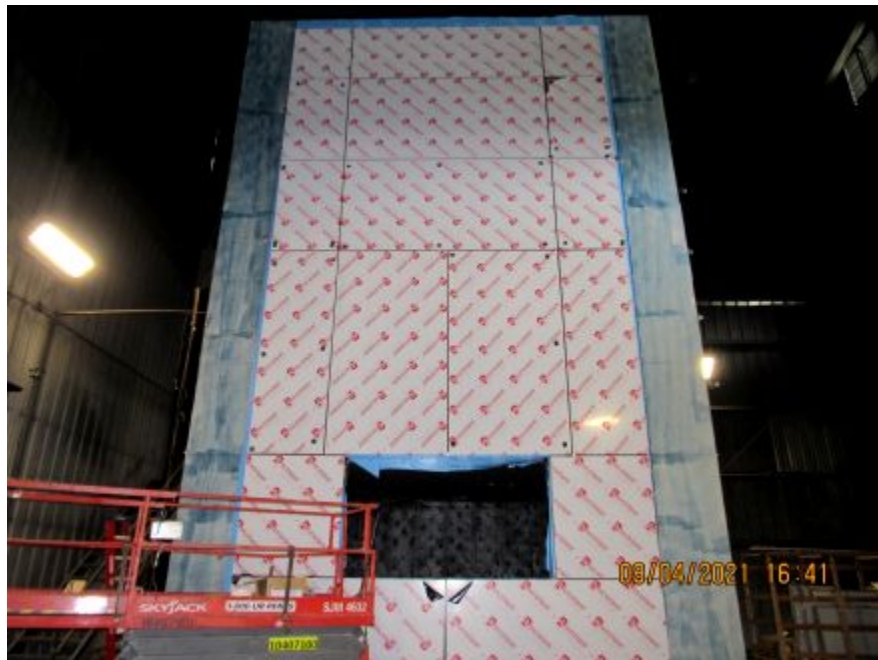
Photo No. 6
Panels installed

Exterior ACM panels were attached to the girts using 2 in. aluminum panel clip extrusions. These were spaced at 16 in. oc. The clip extrusions were installed using 1 in. long panhead self-drilling screws, one screw per panel clip. The panels were installed leaving a nominal 3/4" gap between panels edges, vertically and horizontally.

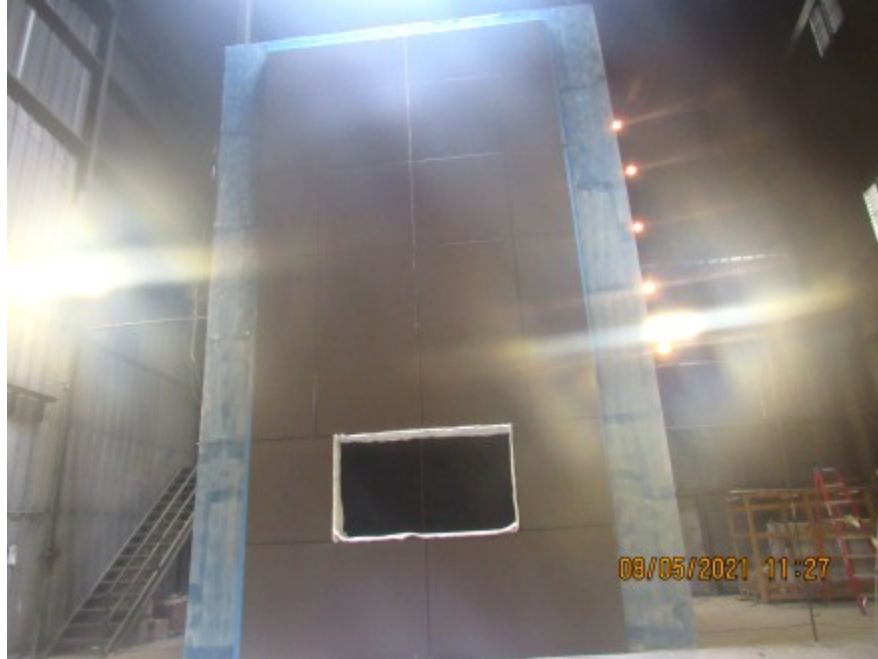
Photo No. 7
Test setup

Three water cooled heat flow transducers (0-100 kW/m²) were installed through the test specimen and the front wall of the test chamber 3.5 m above the top of the window opening; one within 0.2 m ± 0.05 m horizontally of the center line of the opening and one on each side and within 0.5 ± 0.1 m horizontally from the first. The transducers were installed so that their sensing faces were flush with the outer face of the test specimen. 24 GA (0.51 mm), Type K bare beaded thermocouples were used to monitor temperature of the specimen and were located approximately 89 mm to the right of the vertical center line and above the opening at 1.5 ± 0.05 m, 2.5 ± 0.05 m, 3.5 ± 0.05 m, 4.5 ± 0.05 m, 5.5 ± 0.05 m. At each of these levels, one thermocouple

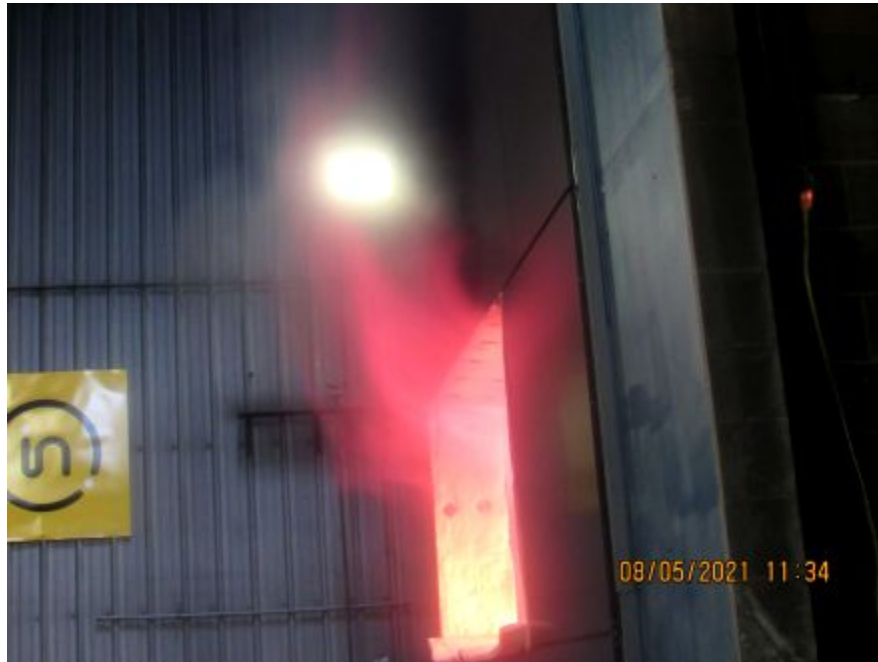
Photo No. 9
Flames exiting window opening

FIRE-RESISTANCE TEST OBSERVATIONS	
Time (min:sec)	Observations
00:00	Test start at 11:32 am
03:27	Flames exiting window
04:22	Panels above window opening warping
04:40	Flame height at 1 meter above opening
08:00	Panels above window opening burning
09:00	Flaming at window header
09:40	Center flame at 2.5 meters above opening
10:20	Debris falling
11:00	Flame tips at 3 meters in center
11:50	Flaming behind panels
15:20	Flaming behind panels at 3 meters
25:00	Gas off, residual flaming at window header
38:00	Flaming at header out
60:00	End of observation period

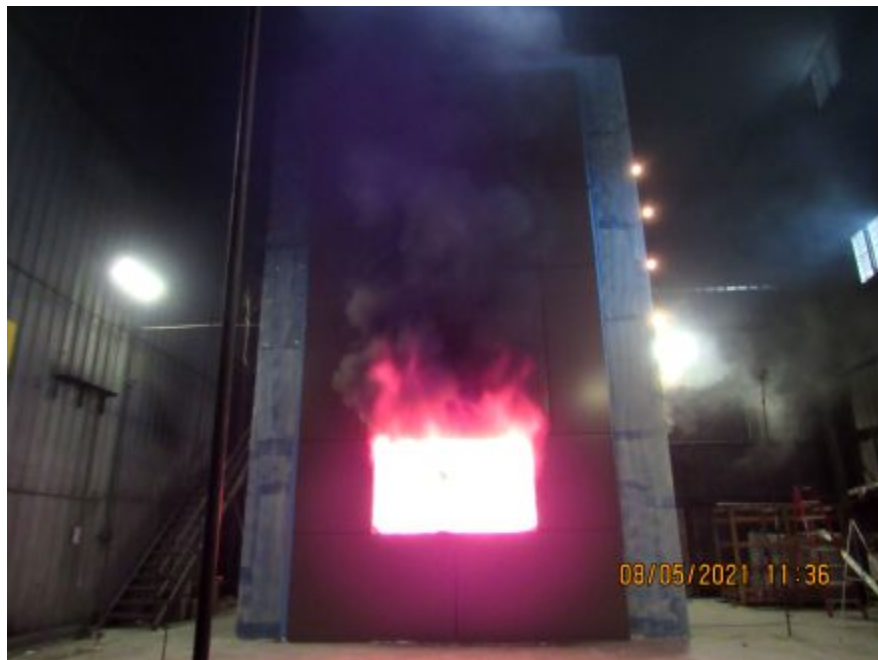
Photo No. 10
Flame tips at 1 meter

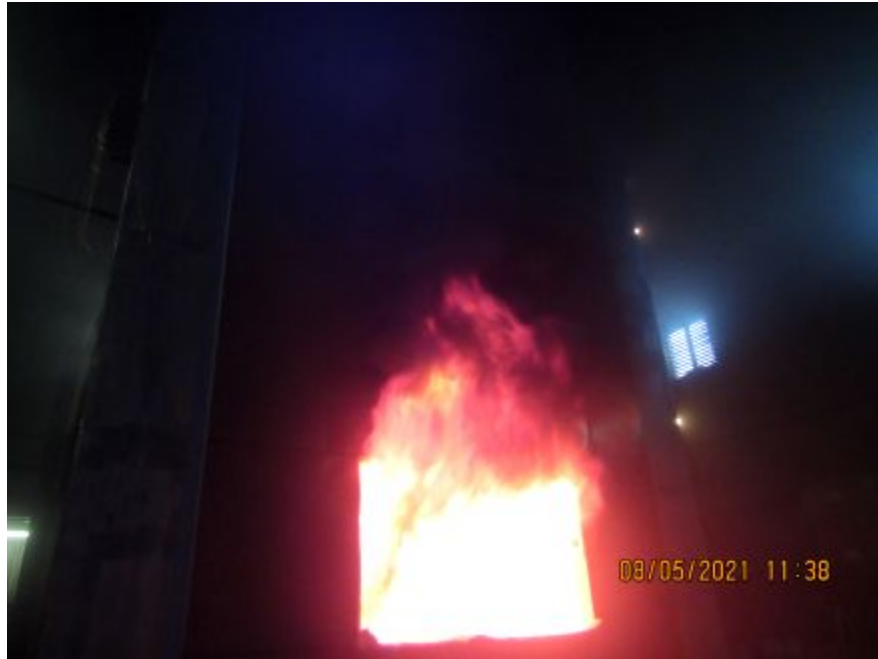
Photo No. 11
Increased flaming

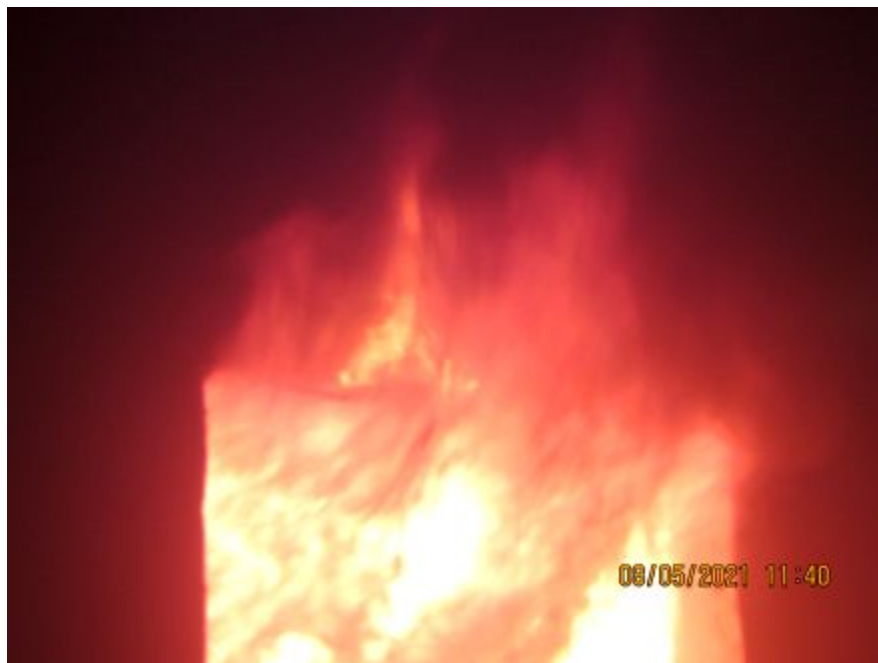
Photo No. 12
Flaming at window header

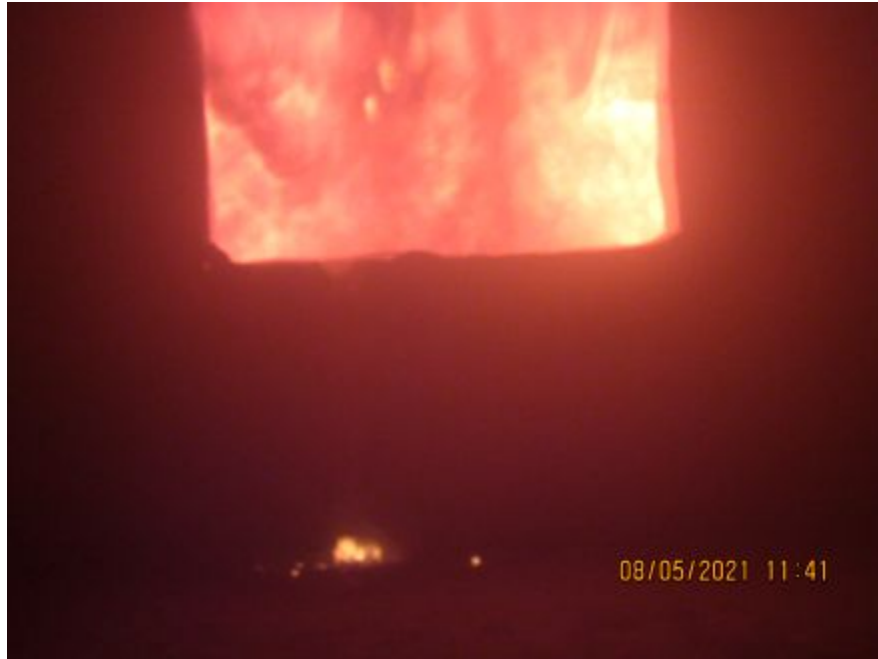
Photo No. 13
Debris falling

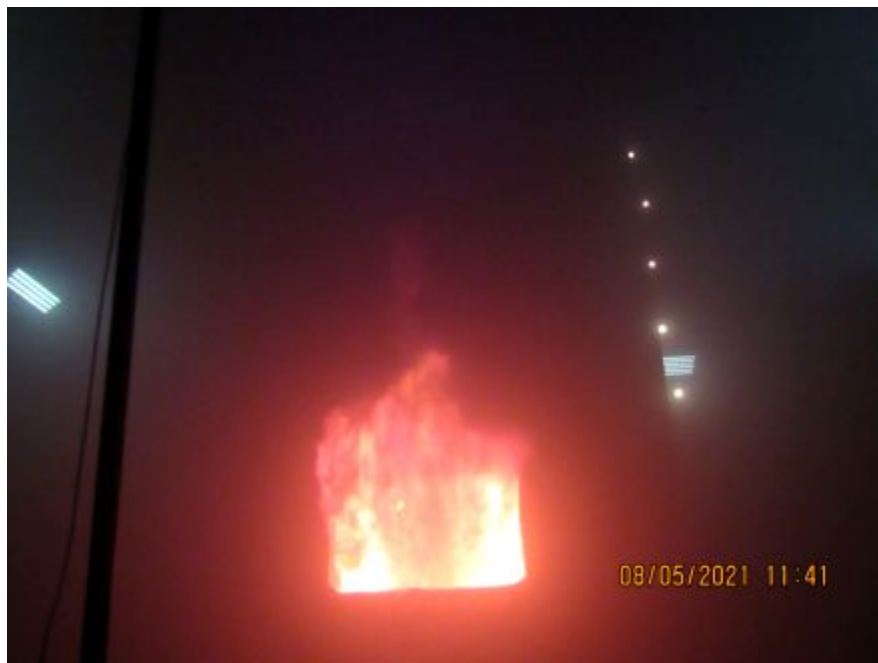
Photo No. 14
Flaming up center to 3 meters

Data for the three radiometers installed at the 3.5 m height above the window is listed in the table below. The maximum flame spread observed above the window opening was 3 m. The maximum average heat flux determined as required by the standard was 32.8 kW/m².

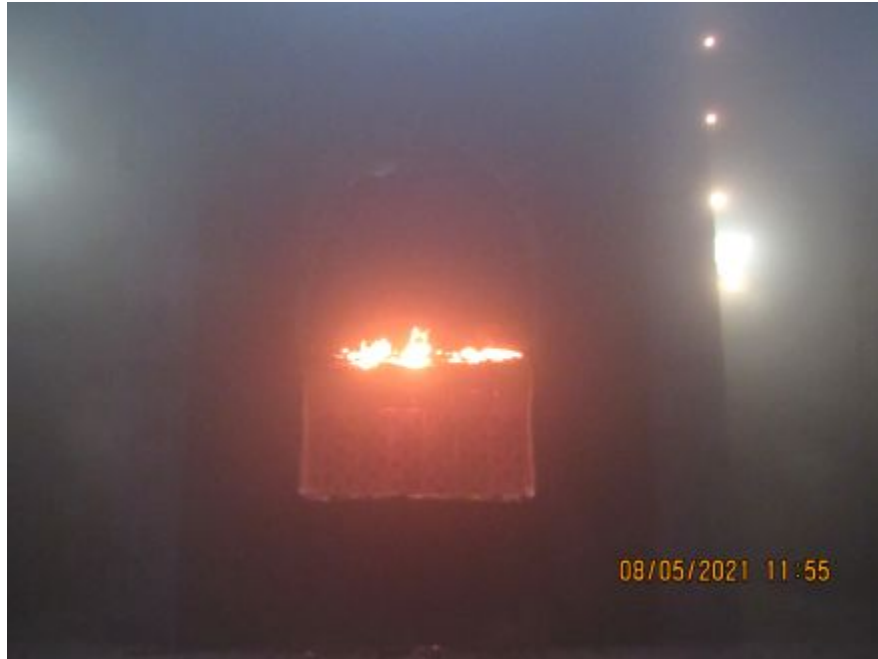
Photo No. 15
Gas off, residual flaming at header

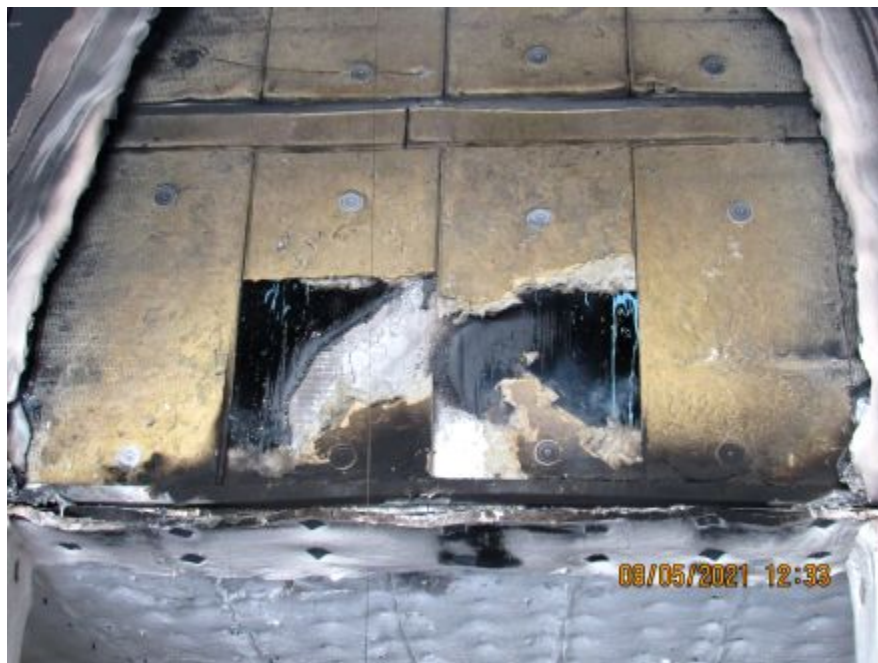
Photo No. 16
Window header post-test

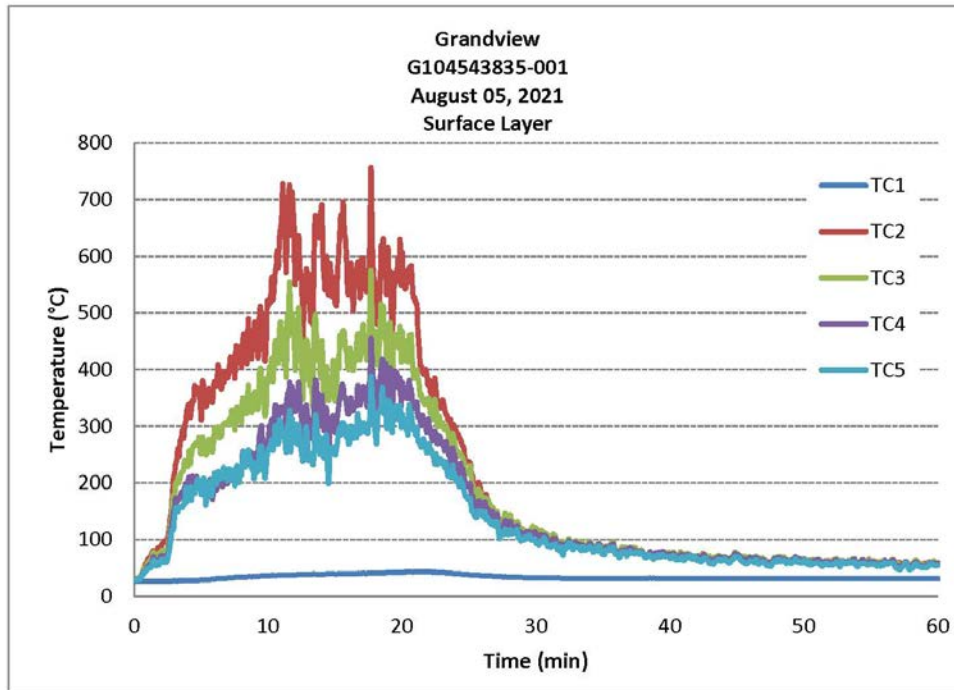
NOTE: TC1 READING AMBIENT TEMPERATURES DUE TO TC WIRES CROSSED AT CONNECTOR

- TCs 1-5: (Layer 1) Flush with exterior ACM panels at 1.5 m, 2.5 m, 3.5 m, 4.5 m, and 5.5 m, respectively.
- TCs 6-10: (Layer 2) On the 2-inch thick mineral wool surface 1.5 m, 2.5 m, 3.5 m, 4.5 m, and 5.5 m, respectively
- TCs 11-15: (Layer 3) On the exterior Henry Blueskin SA water resistive barrier surface at 1.5 m, 2.5 m, 3.5 m, 4.5 m, and 5.5 m, respectively.
